1. AGENCY USE ONLY (LEAVE BLANK)	2. REPORT DATE 5 September 1995	3. REPORT TYPE AND DATES COVERED Professional Paper	
4. TITLE AND SUBTITLE Developing Flight Test Techniques to Ensure Proper Rigging of Highly Augmented Aircraft		5. FUNDING NUMBERS 19951107 055

6. AUTHOR(S) CAPT Ricardo Traven, CAF Susan E. Whitley		8. PERFORMING ORGANIZATION REPORT NUMBER

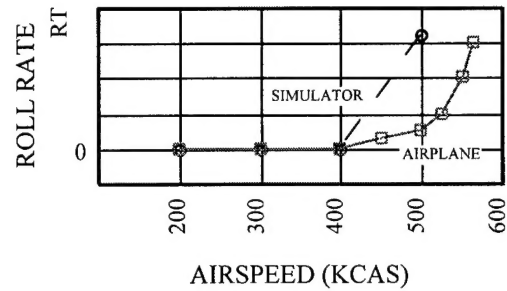
Figure 3
CASE STUDY #1
COMPARISON OF FLIGHT DATA TO
SIMULATOR DATA

One NAWC-AD F/A-18A exhibited a strong tendency to roll to the right after take-off and required constant re-trimming in flight. A standard F/A-18 take-off is in configuration PA1/2. On this airplane, the roll rate in PA1/2 quickly rose to 3 deg/sec by 220 KCAS. Consequently, most pilots started trimming out the uncommanded roll immediately after take-off. When the configuration change to CR was made at approximately 200 KCAS, the uncommanded roll rate should have been zero; however, the trim input while in PA1/2 carried over into CR and trim in the opposite direction was required. Once trimmed for slow speed CR flight conditions, a high speed dash (above 450 KCAS) would result in an unacceptable amount of uncommanded right roll (15 deg/sec by 550 KCAS) that would require re-trimming. Pilots associated the constant requirement for trimming as behavior indicative of a "bent" airplane. When the NAWC-AD test team compared the in-flight data to the simulator data (figure 3), the LEF's were identified as the probable cause of the uncommanded roll rate.

An initial check of the LEF rigging confirmed that the LEF's were correctly rigged to the center of the reference rivet. The rigging of the LEF's was adjusted to counter the uncommanded roll rate. The left LEF was raised 0.04 inches to the top of the reference rivet and the right LEF was lowered 0.04 inches to the bottom of the reference rivet. These changes are within the published tolerance band for rigging the LEF's. The flight test results for the CR configuration before and after the re-rig are presented in figure 4. The uncommanded roll rate was reduced to less than 5 deg/sec at speeds up to 550 KCAS. NAWC-AD pilots now find the handling qualities of this F/A-18A acceptable for all flight profiles.

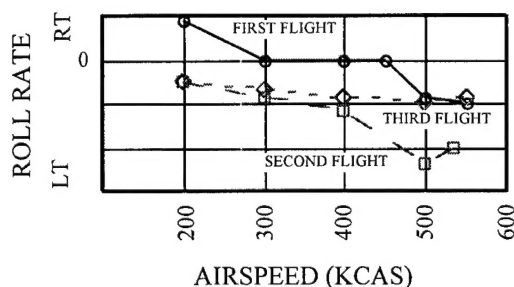
Figure 5
CASE STUDY #2
CR FLIGHT DATA

The airplane was flown prior to the first rigging to assess the handling qualities of the airplane and to quantify the complaints of the squadron pilots. The airplane exhibited a strong tendency to roll and yaw to the right above 25 deg AOA. By

35 deg AOA, the right roll and yaw rates were uncontrollable, as characterized by the NAWC-AD test pilot. Figure 5 presents the roll rate data and figure 6 presents the maneuvering flight data. The maneuvering flight data (figure 6) confirmed the squadron's most significant complaint, which was the inability to perform straight loops or any left rolling scissors maneuvers above 25 deg AOA and below 150 KCAS.

A second flight was flown on the airplane after a complete re-rig of the flight control surfaces. The results from this flight are presented in figure 5. While the CR roll rate trace shows a significant amount of roll

The data from the final flight are presented in figures 5 and 6. The roll rate in configurations PA and PA1/2 was reduced to insignificant levels (< 2 deg/sec) and the highest roll rate observed in configuration CR was 5 deg/sec. This was considered acceptable by the NAWC-AD team. The yaw rate at high AOA during maneuvering flight was greatly reduced. The NAWC-AD test pilot was able to perform slow speed "over the top" maneuvers with no difficulty. Left rolling scissors, once impossible, were now easily flown at speeds below 150 KCAS and above 25 deg AOA.

rate, the overall aircraft handling qualities were an improvement over those reported by the squadron's pilots. There was no maneuvering flight data collected on this flight; however, the NAWC-AD test pilot reported that although the yaw rate problem at high AOA was not ideal, it was tolerable. A comparison of the simulator data to the data from the second flight revealed that the probable cause was a TEF mis-rig in the mid-speed range and a LEF mis-rig in the high speed range. The NAWC-AD test pilot also noted that in flight the outboard LEF's were noticeably out of alignment with respect to the inboard LEF's, due to the effects of air loads on the LEF freeplay. The TEF's and the outboard LEF's were adjusted to correct the adverse handling qualities.
